# High Performance Materials For Civil Engineering Structures

Issam E. Harik  
Raymond Blythe Professor of Civil engineering, and  
Program Manager, Structures and Coatings, Kentucky Transportation Center  
University of Kentucky  
Lexington, KY 40506-0281, USA  
Telephone: 859-257-3116  
e-mail: [iharik@engr.uky.edu](mailto:iharik@engr.uky.edu)

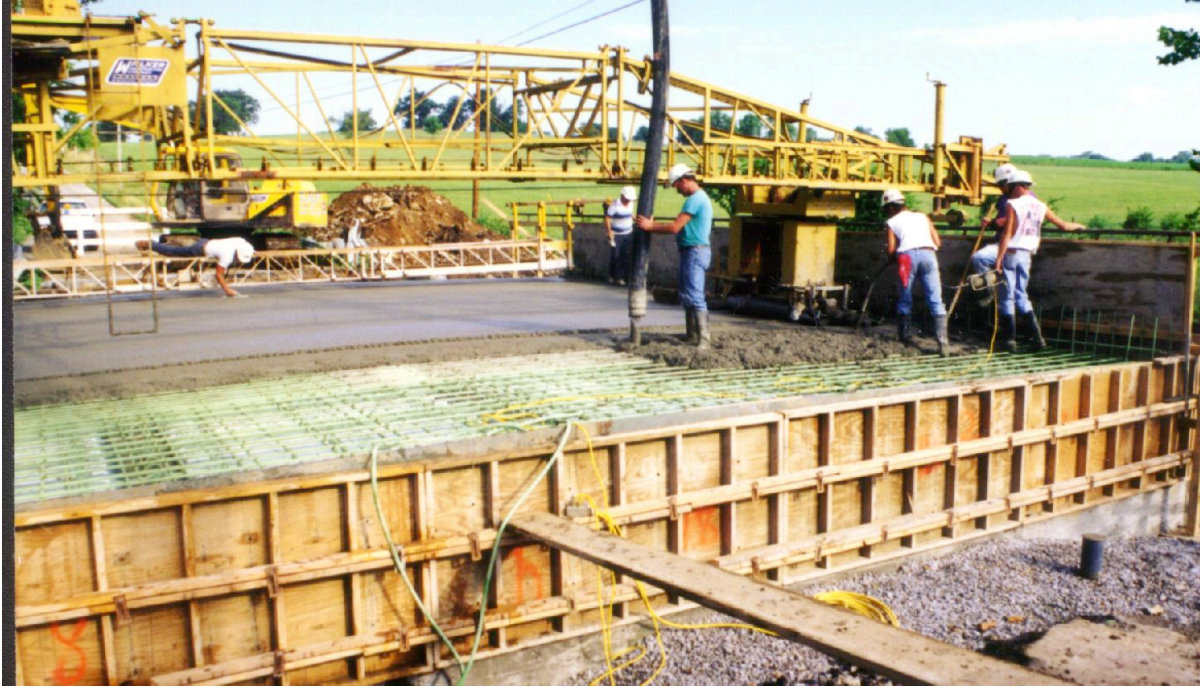
**Fig. 1:** Concrete placement on the Roger's Creek bridge deck

A bridge deck 11.2 m long and 11.0 m wide was constructed in 1997 across Roger's Creek in Bourbon County, Kentucky with GFRP rebars in a region of the top reinforcing mat as shown in Fig. 1 [5]. The remainder of the top mat was reinforced with epoxy coated steel (ECS) bars. The bridge is being monitored on a regular basis (i.e. evaluate crack formation, crack width, crack propagation, etc). To date, no sign of distress has been reported and the bridge is reportedly in excellent condition [6].

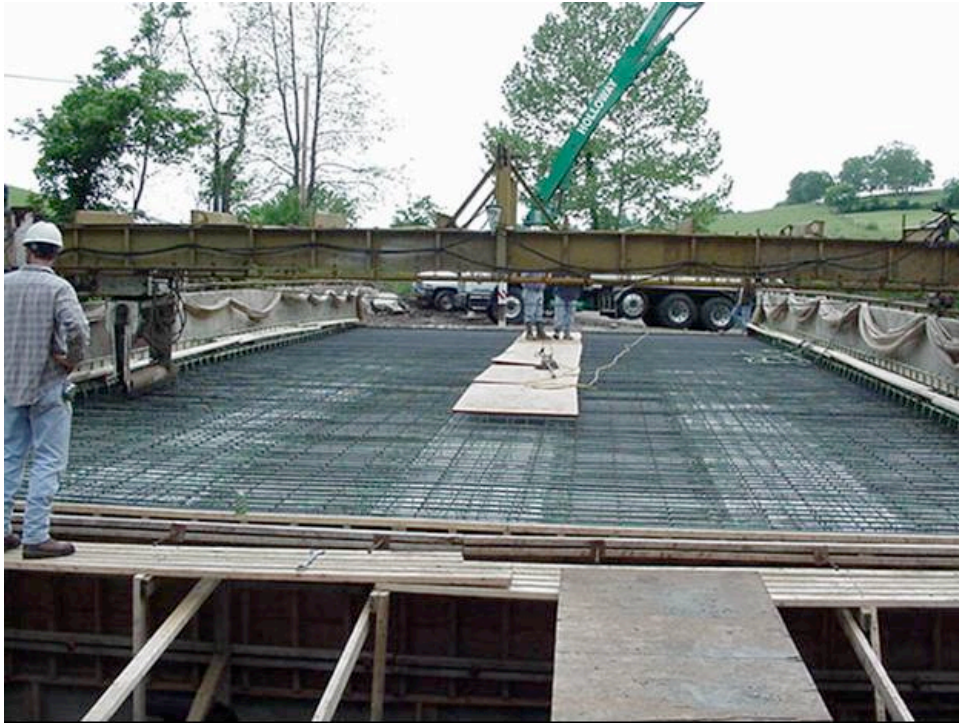
**Fig. 4:** The Two Mile Creek bridge deck prior to concrete placement
